Inspection Report
Minerals Regulatory Program
Report Date April 4, 2006

Mine Name: D Tract
Operator Name: Wembco

Permit number: M0470068
Inspection Date: March 21, 2006
Time: 4:55-5:25 PM

M0470068, D Tract, Wembco

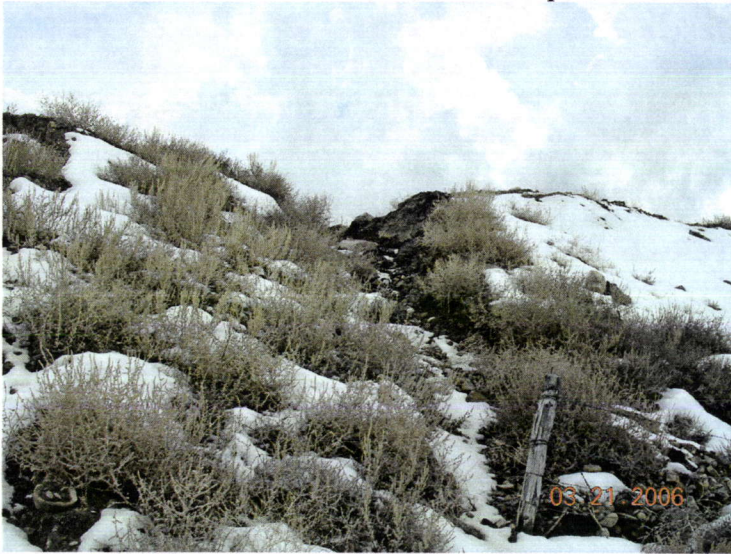
There are a few places where the overburden piles have eroded a few feet deep. Sediment from this erosion flows onto a adjacent road and into a small ephemeral drainage, but I do not believe it causes much damage. It appears water gathers on the pad adjacent to the pit then flows this direction.

Photo 1. Erosion on the outslope of the overburden pile.

I recommend that the operator consider how water flow could be directed to reduce erosion on the overburden piles. There is a place on the pad from which it appears the operator has been taking material for use in asphalt recycling, and it might be possible to direct the water to this area. Berms at the edge of the pad might also be heightened so they hold more water

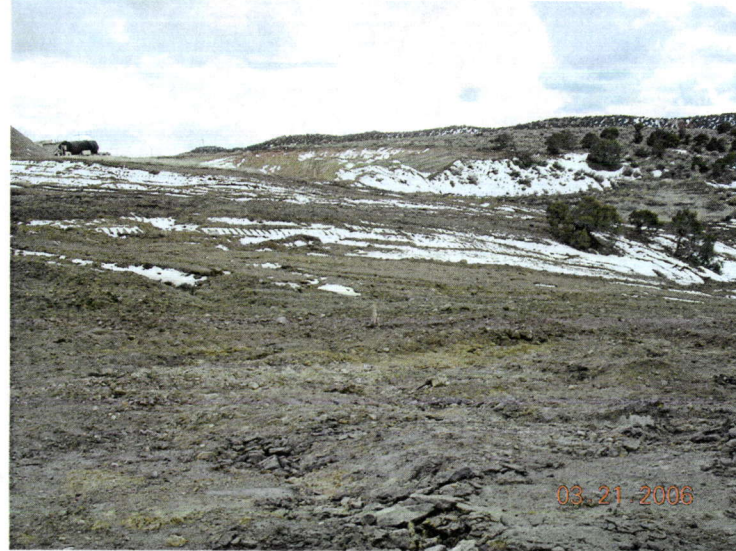
The operator was required to grade and seed an area of about 0.76 acres, and this has been done. The area blends well with surrounding areas, and I was able to find seed. The only species I saw was crested wheatgrass, but others could have been there. I saw no sign of germination, but it is still early in the season, particularly this year when temperatures have stayed cool.

Photo 3. A portion of the area the operator has reclaimed.

The surface should be left extremely rough when doing revegetation. This helps to capture water and increases infiltration and vegetation establishment while decreasing erosion and sedimentation.

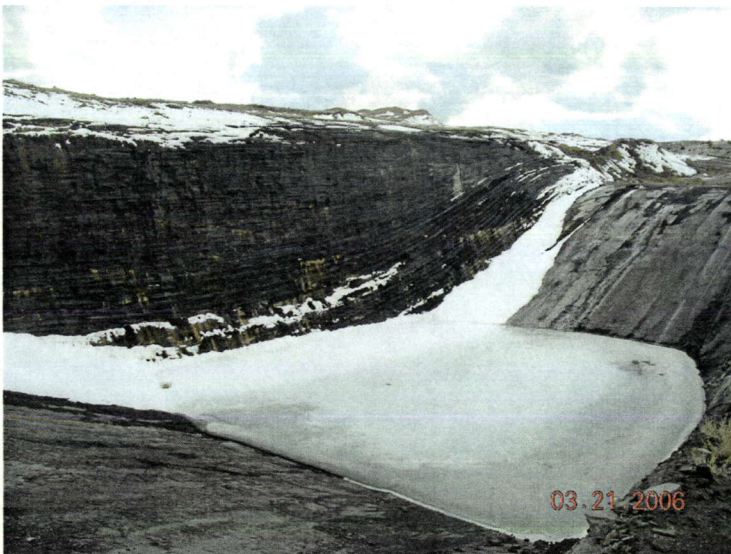
I could not tell that there had been any recent mining activity, but I understand the operator of a pilot oil extraction plant obtained his material from this mine.

Photo 2. The mine pit. This has changed little, if at all, since the last inspection.

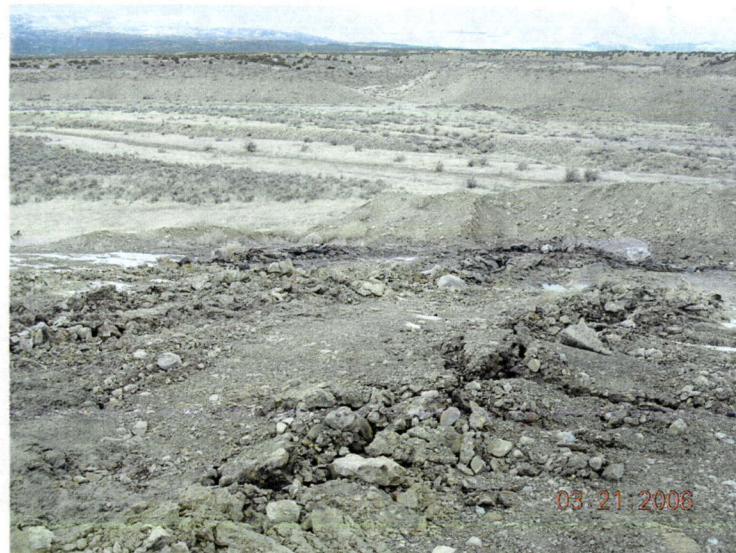
Photo 4. Another part of the reclaimed area.

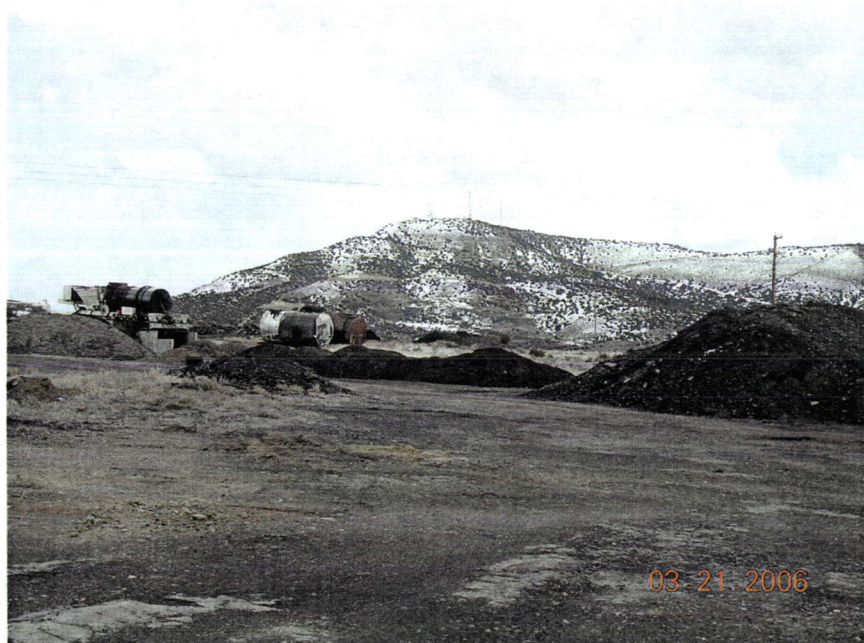
The operator continues to use a stationary batch plant to process recycled asphalt at this site.

Photo 5. The hot plant and nearby stockpiles.

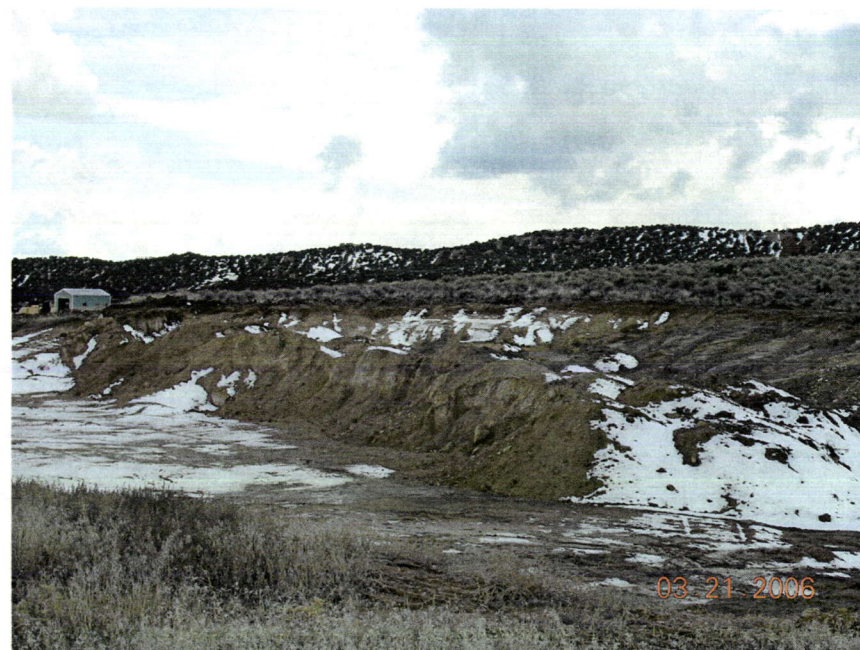
Photo 6. An area adjacent to the mine that has been mined for sand.
